Time, Safety, Accessibility:

The Cost of Blocking the Bus

October 2023

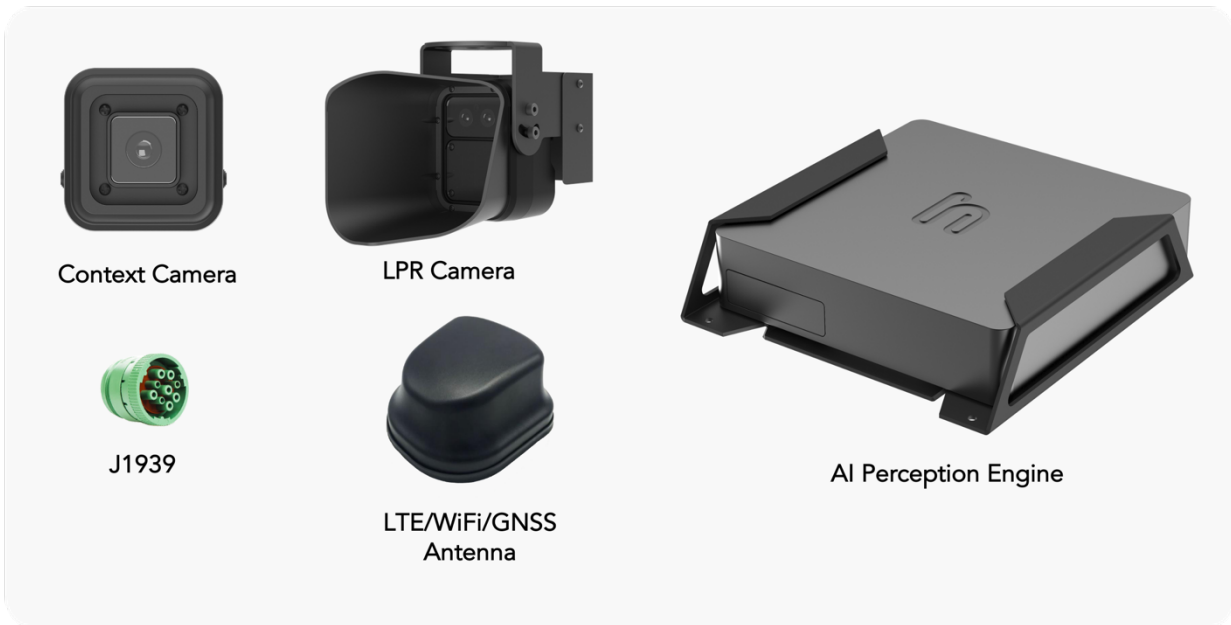
The camera-assisted enforcement technology system tested in this study utilized a camera system installed behind the windshield of each of the seven buses participating in this pilot. The system utilized computer vision technology to recognize and capture images of vehicles obstructing bus lanes and bus stops.

Figure 3 – Camera-assisted enforcement technology system

Camera-assisted bus-mounted enforcement has proven to be an effective solution to the problems posed by illegal parking in transit zones. This type of enforcement uses camera systems to detect instances of illegal parking on transit corridors. Once an obstruction is detected, an evidence package documenting the incident is created and sent securely to a parking enforcement officer for review. Only a parking officer has the power to determine if an actual parking violation occurred. Once the parking officer makes their evaluation, a citation is issued to the registered owner of the vehicle. Parking officers are critical to the success of these technology-assisted enforcement programs, as they are needed to review evidence packages generated by the technology.

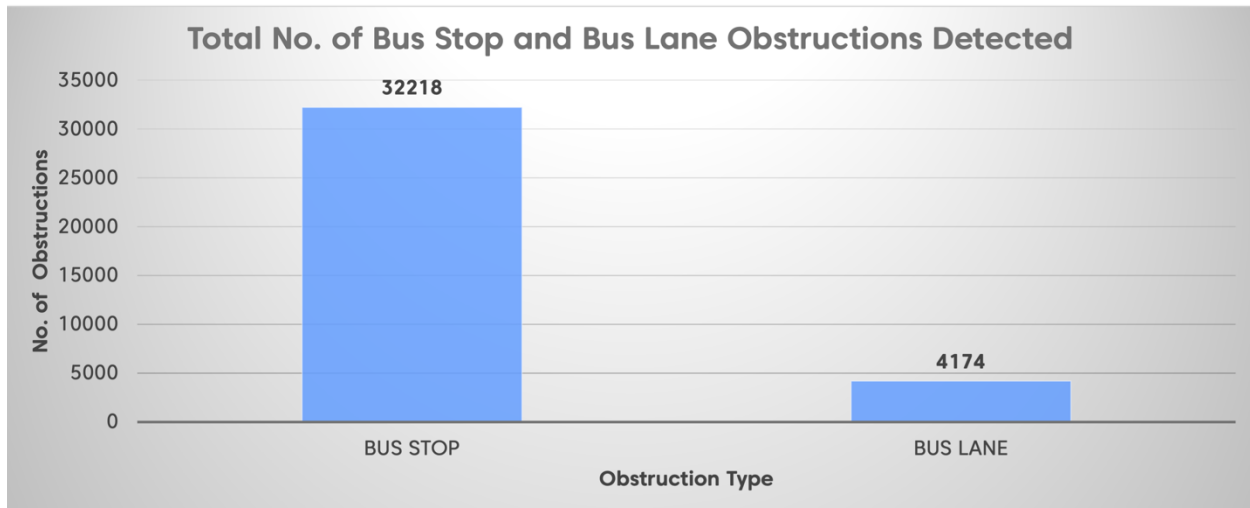
Figure 5 - Total Number of Bus Stop and Bus Lane Obstructions Detected*

In total, the seven equipped buses detected 36,392 obstructions during the pilot. Instances of obstructed bus stop zones were more frequent than detection of obstructed bus lanes. The study focused on bus stop obstructions through the West Philadelphia and Upper Darby portions of Routes 21 and 42, and bus lane obstructions in Center City. In Center City, when a vehicle was obstructing both a bus lane and also a bus stop in the bus lane, it was counted as only a bus lane obstruction.

* The numbers in Figures 5 -12 reflect total obstructions detected by buses participating in the study. Some of the obstructions were detected more than once per day. Parking citation rules vary by jurisdiction regarding how many parking tickets may be issued to the same vehicle within a certain time period. However, if one ticket per calendar day were applied to the entire study, a total of 18,141 potential violations would result.

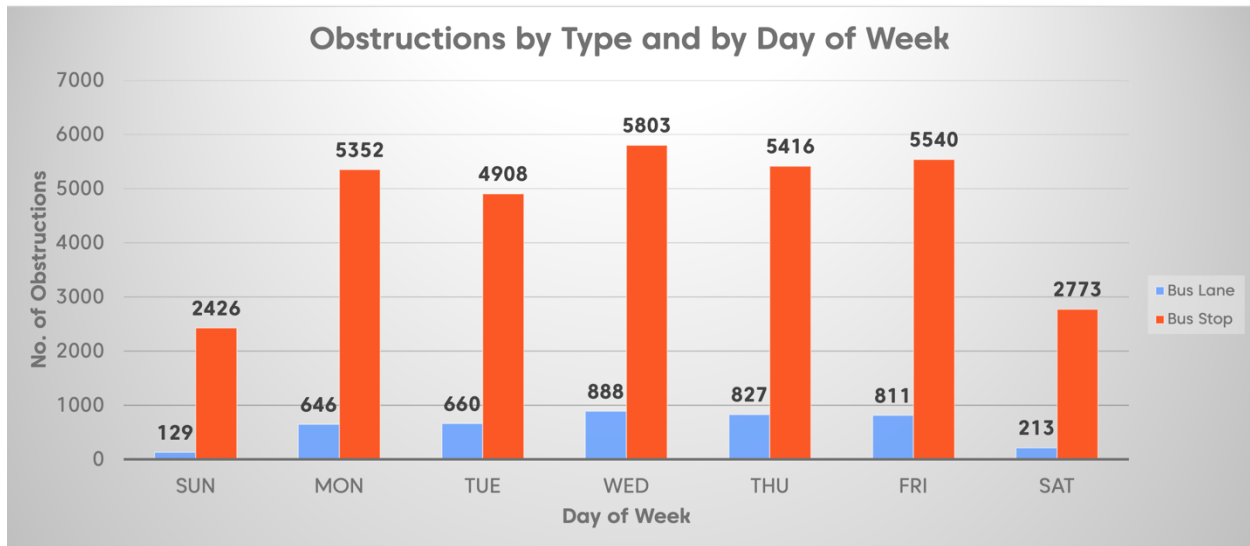
Figures 6 and 7 below show the distribution of obstructions detected by day of the week and time of day. While the variations in the data are likely in part the result of the frequency of bus runs at a given time or on a certain day rather than volume of obstructions, it is indicative of individual instances of a bus encountering an obstruction during the course of this study. The data also indicated a slight decline in obstructions over the study period after the summer transit schedule adjustments occurred in June. This could in part be the result of expected reductions in business, student, and travel activity during the summer months.

Figure 6 - Obstructions by Type and by Day of Week

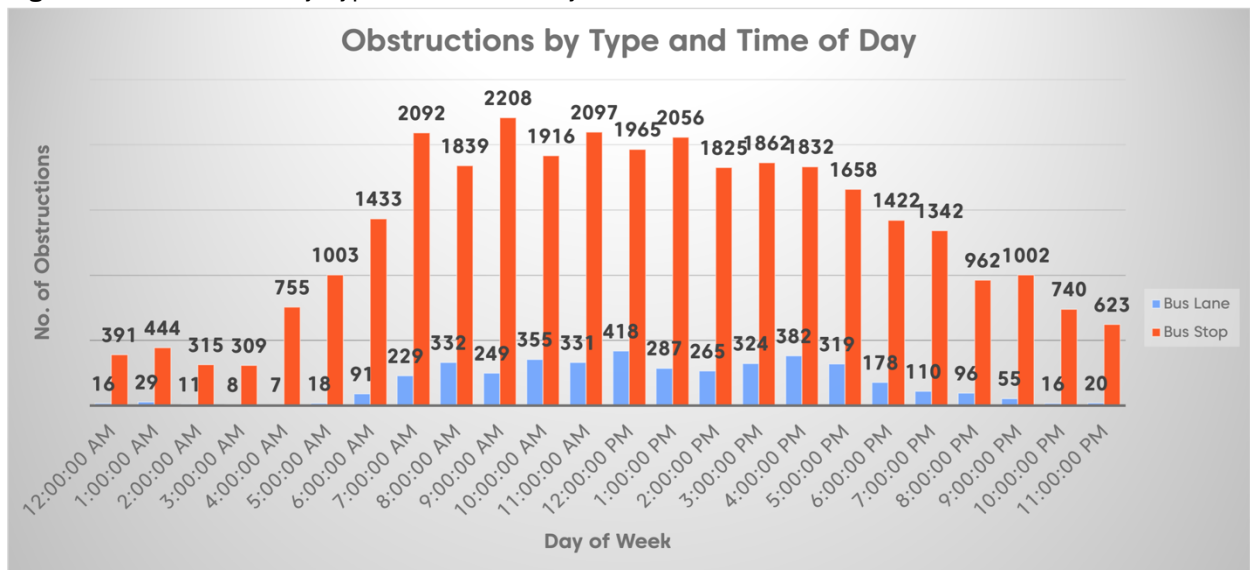
Figure 7 - Obstructions by Type and Time of Day

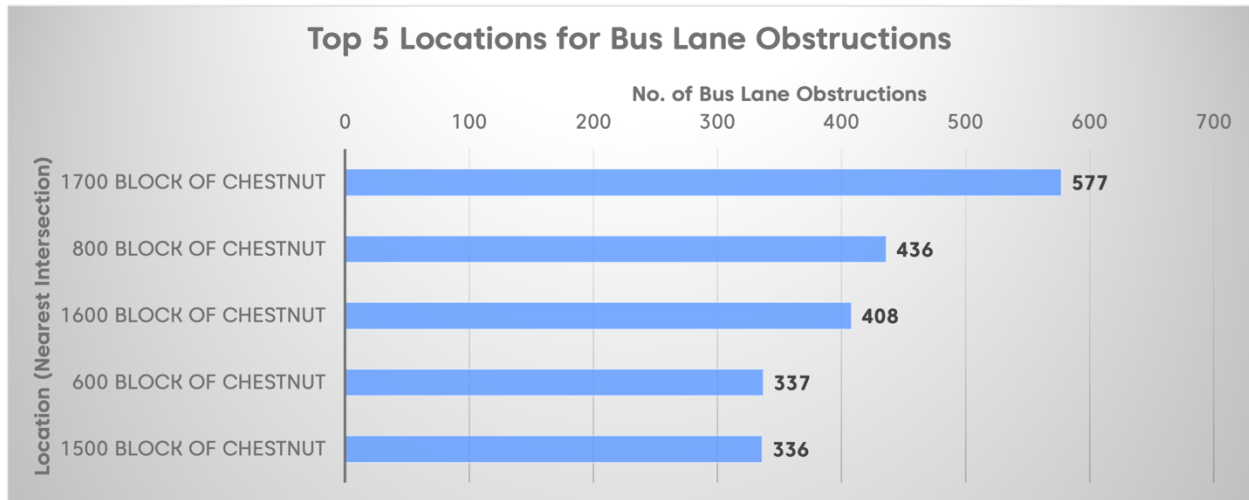
The study revealed that there are several blocks on Chestnut Street in Center City that are chronically obstructed, preventing the efficient and safe use of the bus lane. These blocks are obstructed to such an extent that SEPTA buses are often required to move into the general traffic lane, undercutting the purpose of the bus lanes, delaying riders and creating risks to safety.

Figure 8 - Top 5 Locations for Bus Lane Obstructions

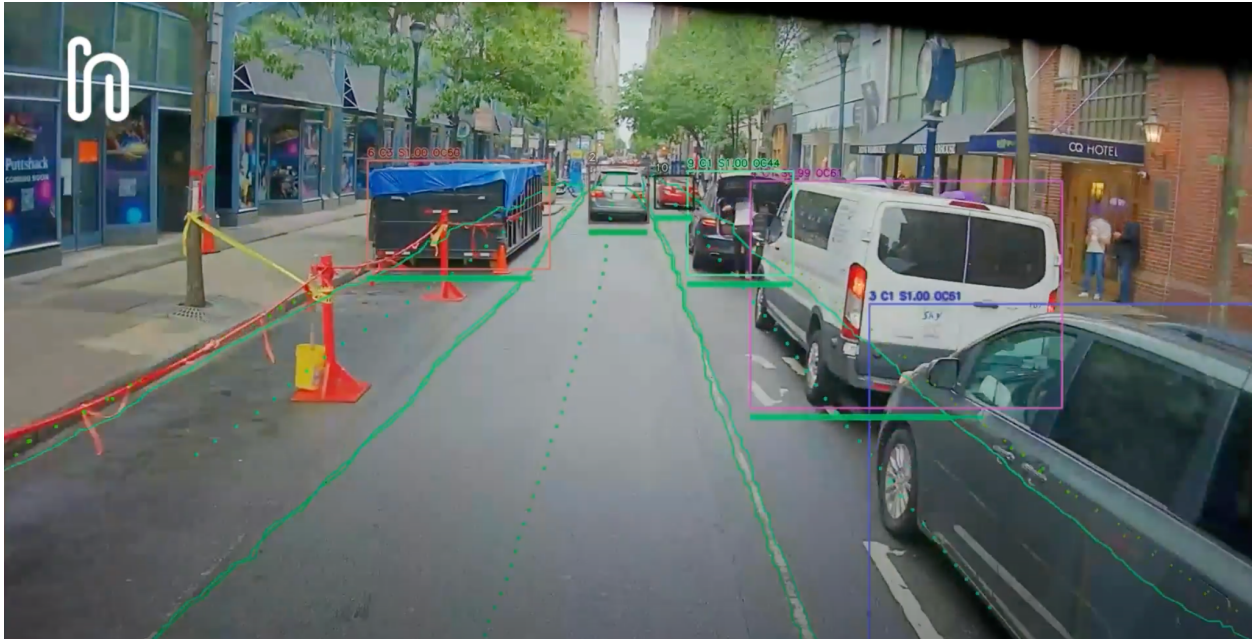
Image 1 shows multiple vehicles blocking nearly the entire bus lane on the 1600 block of Chestnut Street in Center City, which is the third most frequently obstructed bus lane location. The Chestnut Street bus lane between 16th to 18th Streets was so frequently blocked during this study that this corridor was often unusable as a functional bus lane.

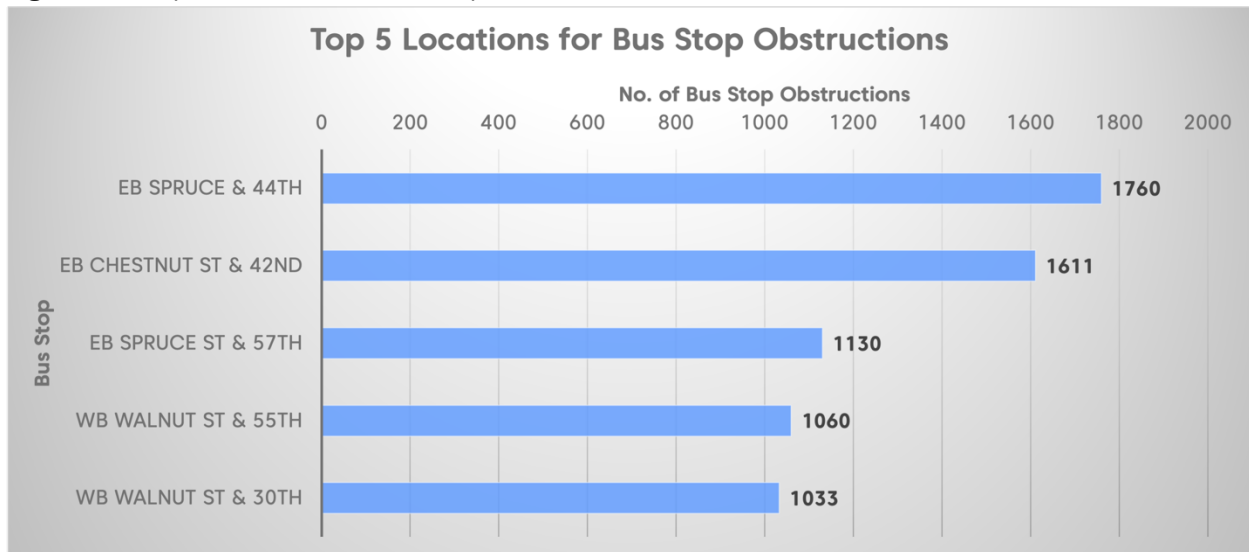
Figure 11 - Top 5 Locations for Bus Stop Obstructions

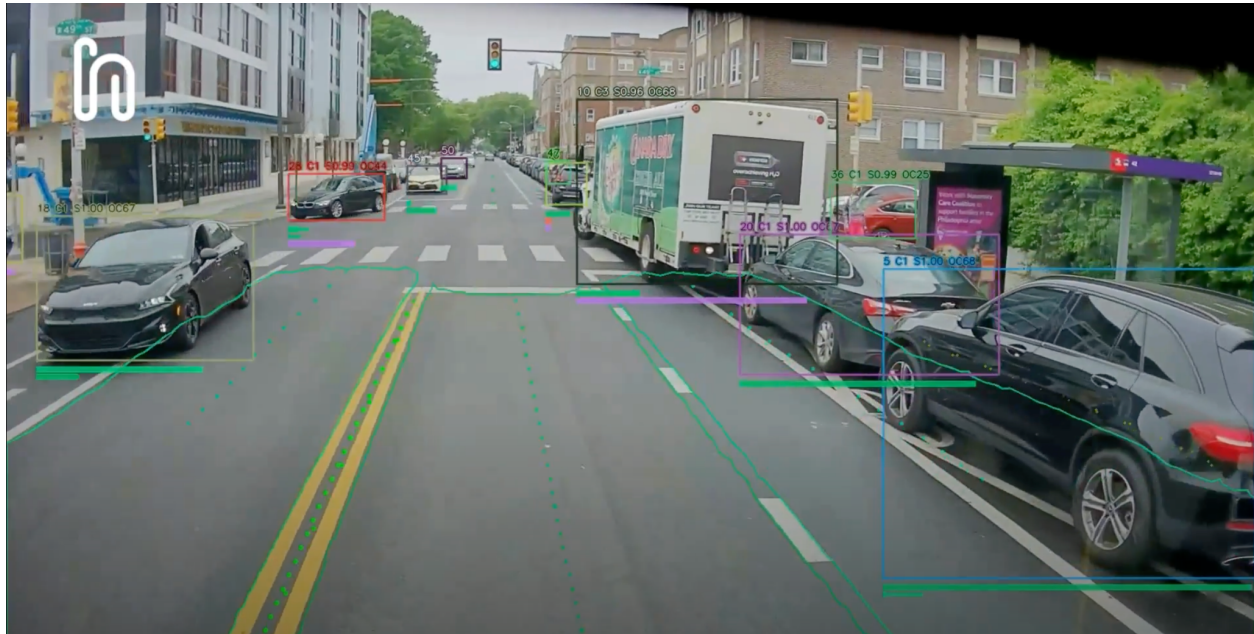
Image 2 below shows the westbound bus stop at Spruce Street and 49th Street, served by Route 42, obstructed by multiple illegally parked vehicles. In addition, the image indicates that both the bus stop **and the pedestrian curb ramp** are obstructed. In this case, it is impossible

for riders boarding or exiting to avoid walking in the street or for a wheelchair or other mobility-assistive devices to safely access the curb.

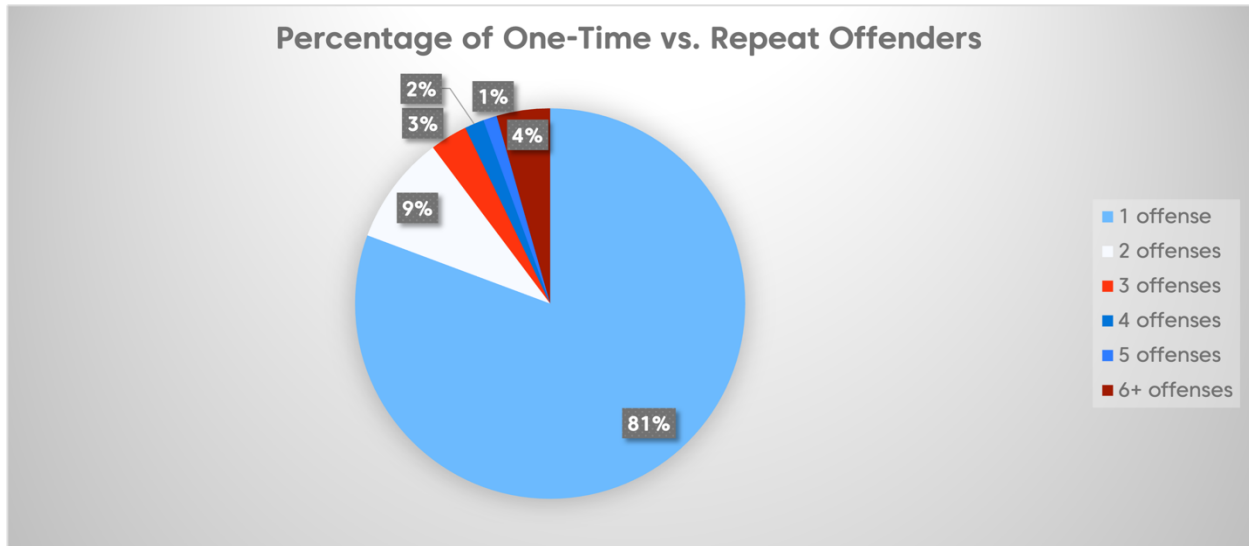
The study also found a significant number of vehicles causing obstructions on different days during the period of this study. As indicated below in Figure 13, 21 percent of vehicles committing obstructions did so on multiple days.

Figure 13 - Percentage of One-Time vs. Repeat Offenders

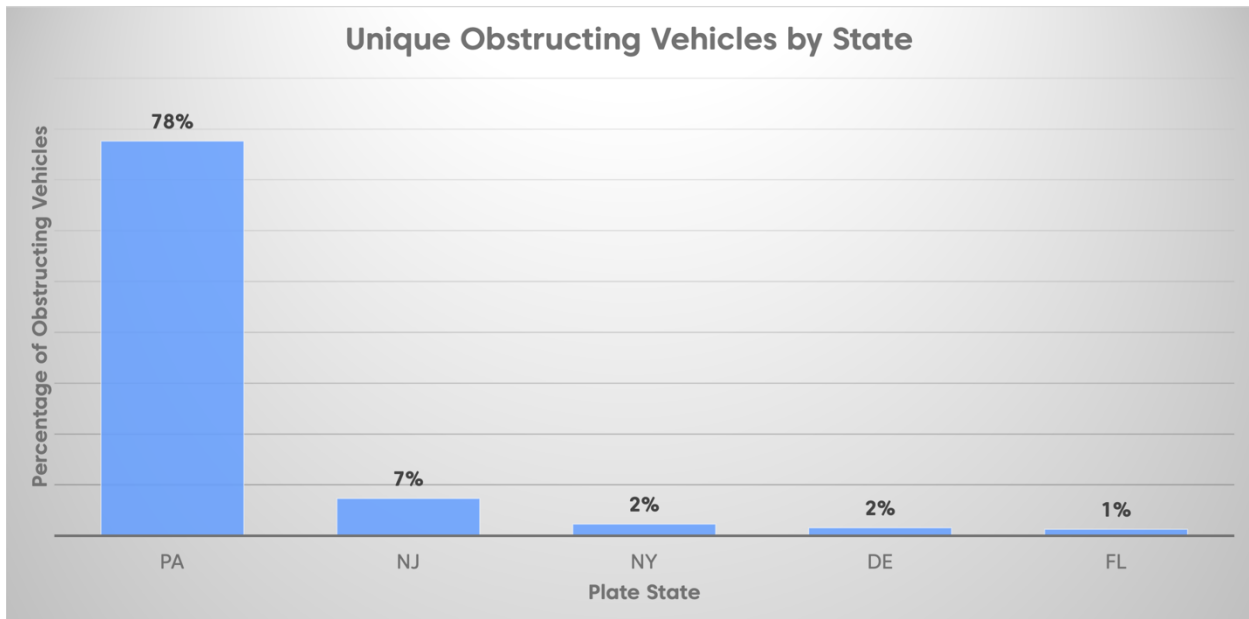
Of the total list of vehicles that obstructed a bus lane or bus stop during this pilot, Figure 14 shows the percentage of Pennsylvania registered vehicles compared to other states. During the course of this study, one in five of all vehicles obstructing transit had out-of-state license plates, with New Jersey at 7 percent.

Figure 14 - Unique Obstructing Vehicles by State
